INDOOR AIR QUALITY ASSESSMENT

**Department of Public Works
35 Parsonage Street
Marshfield, MA**

Prepared by:
Massachusetts Department of Public Health
Bureau of Environmental Health
Indoor Air Quality Program
November 2018

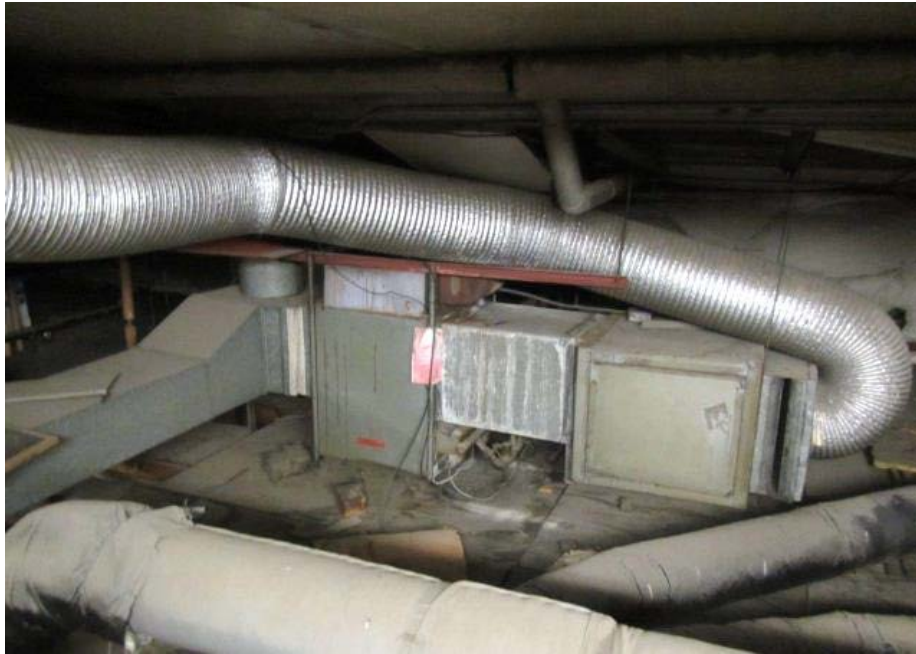
Picture 1

Finally, The AHUs appear to be at least 20 years old. Efficient function of equipment of this age is difficult to maintain, since compatible replacement parts are often unavailable. According to the American Society of Heating, Refrigeration, and Air-Conditioning Engineering (ASHRAE), the service life¹ of this type of unit is 15-20 years, assuming routine maintenance of the equipment (ASHRAE, 1991). It appears the optimal operational lifespan of this equipment has been exceeded.

One of two air handling units (AHUs) above office space, note age/condition of unit and open panels

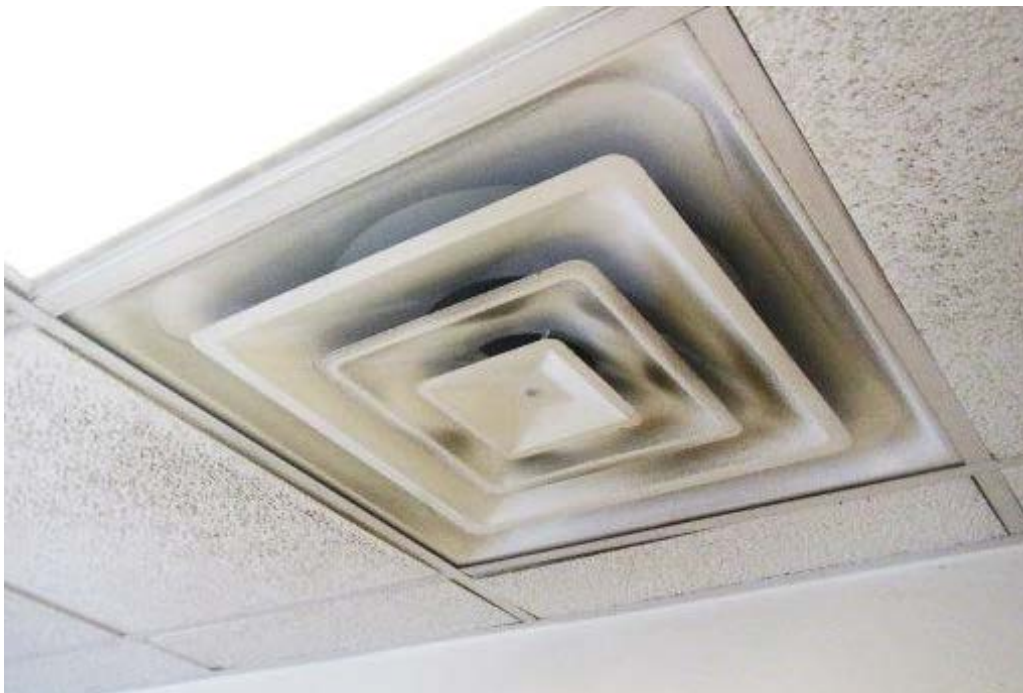
Picture 2

AC supply diffuser in office, note dust/debris on louvers

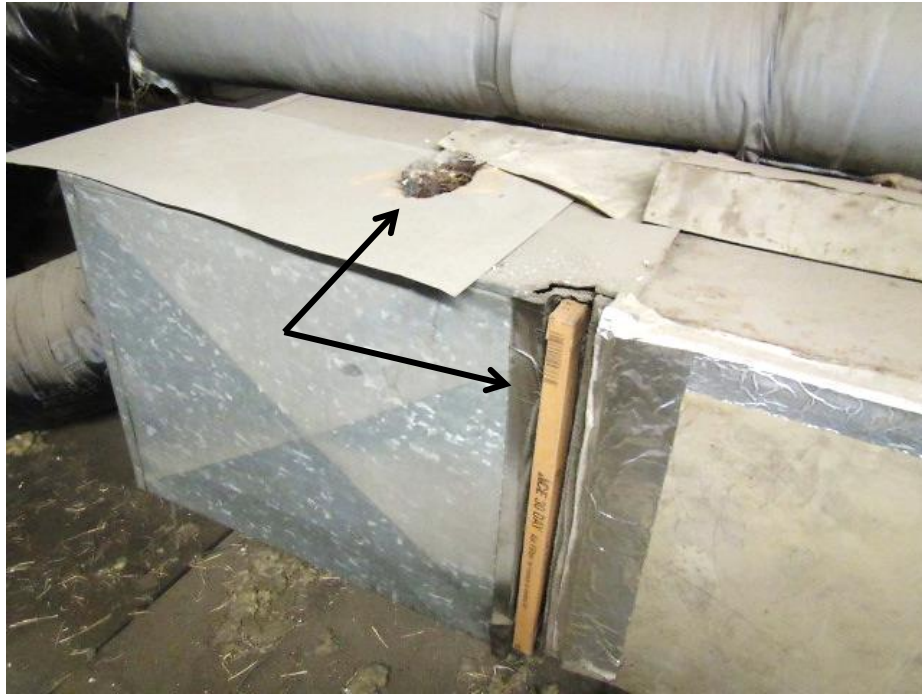
Picture 3

Of primary note were dead birds and bird wastes observed inside the building (Pictures 3 through 6, 36, and 37). Bird wastes in a building raise concerns over diseases that may be caused by exposure to bird wastes. These conditions warrant clean up of bird waste and appropriate disinfection.

Dead bird and open filter panel on AHU (arrows)

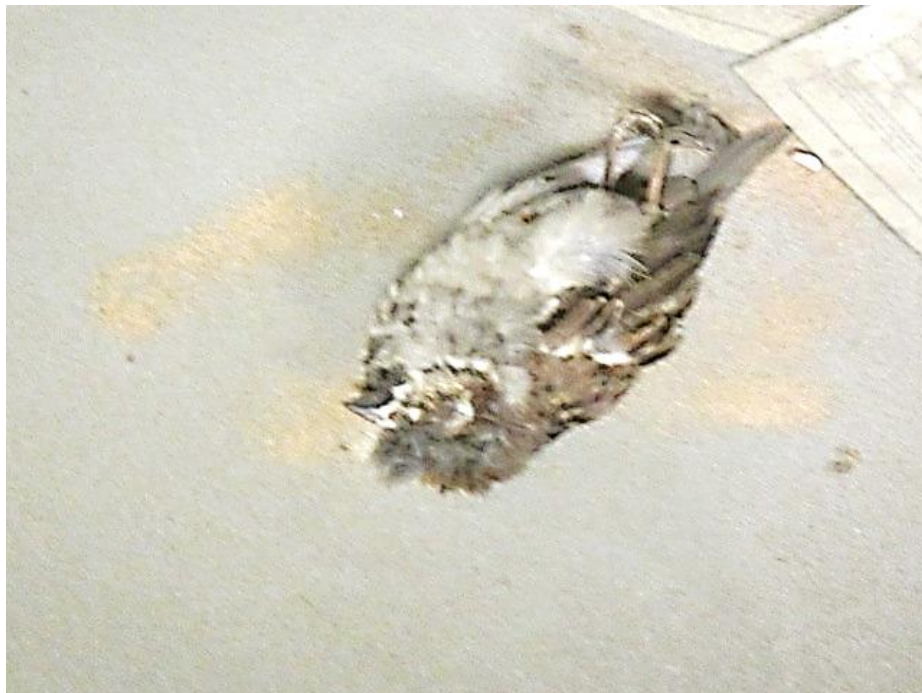
Picture 4

Close-up of dead bird on AHU

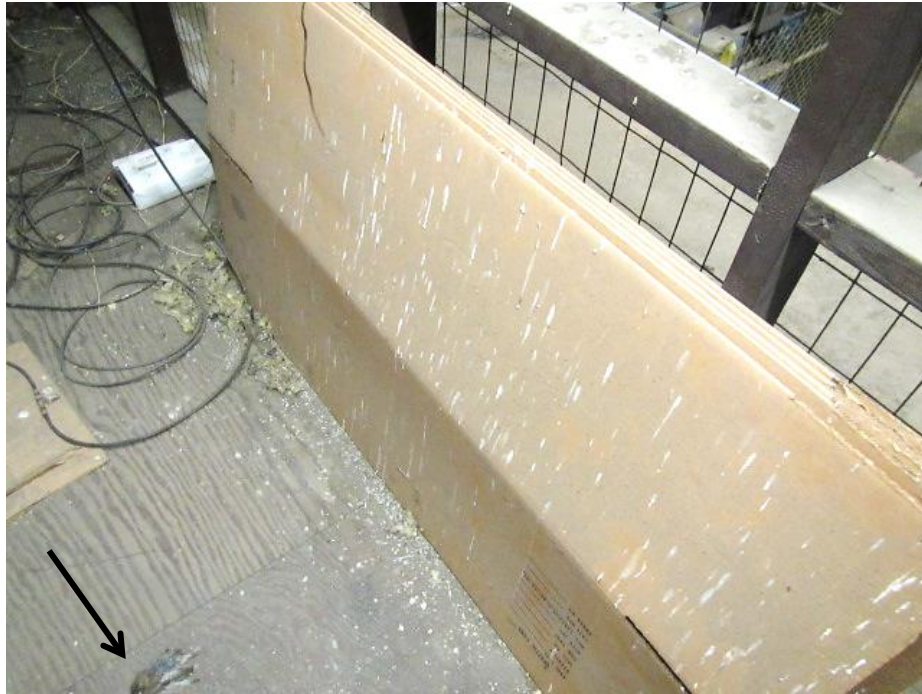
Picture 5

Dead bird (arrow) wastes and nesting materials near AHU/loft

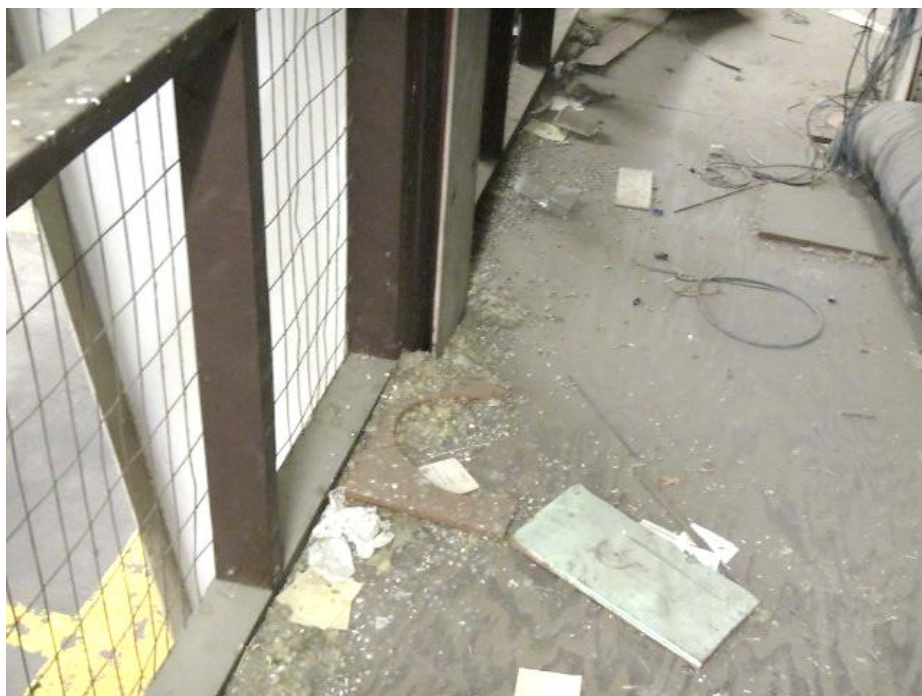
Picture 6

Bird wastes and nesting materials near AHU/loft

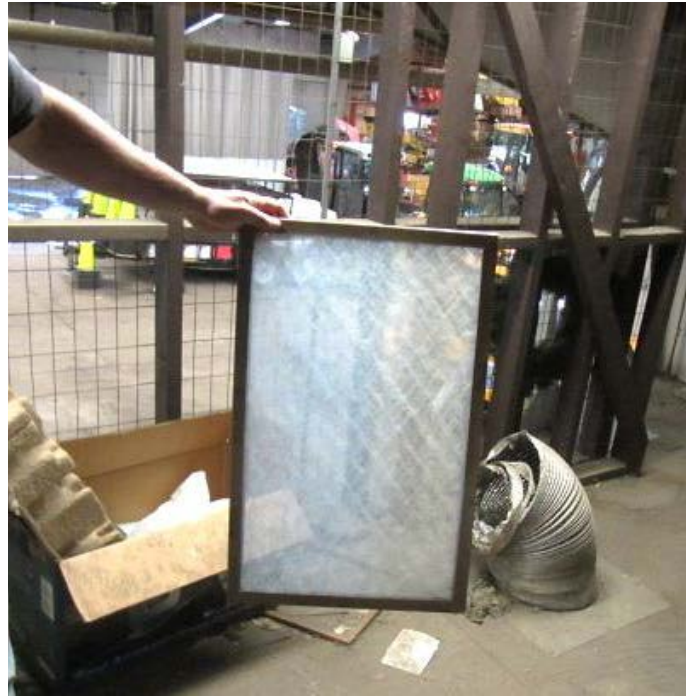
Picture 7

The filters in the AHUs were examined. The mesh-style filter (Picture 7) has minimal efficiency to remove airborne particulates and is not recommended. The MDPH recommends pleated filters with a Minimum Efficiency Reporting Value (MERV) of 8, which are adequate in filtering out pollen and mold spores (ASHRAE, 2012). Note, however, that an increase in filtration can cause stress on equipment, which needs to be evaluated to determine if the higher-rated filters will allow adequate function. Filters should also be changed two to four times a year, or per the manufacture's recommendations. It is also important to note that the box of filters stored in this area was covered in dust/debris and open to potential contamination (Picture 8), thus should be discarded.

Low efficiency mesh filter

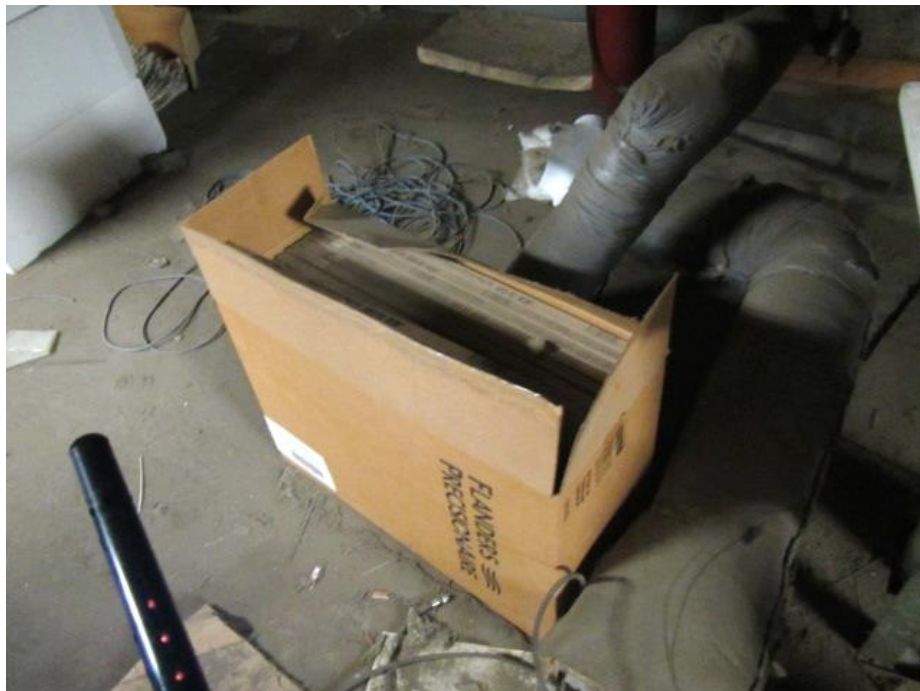
Picture 8

Open box of filters in loft above office

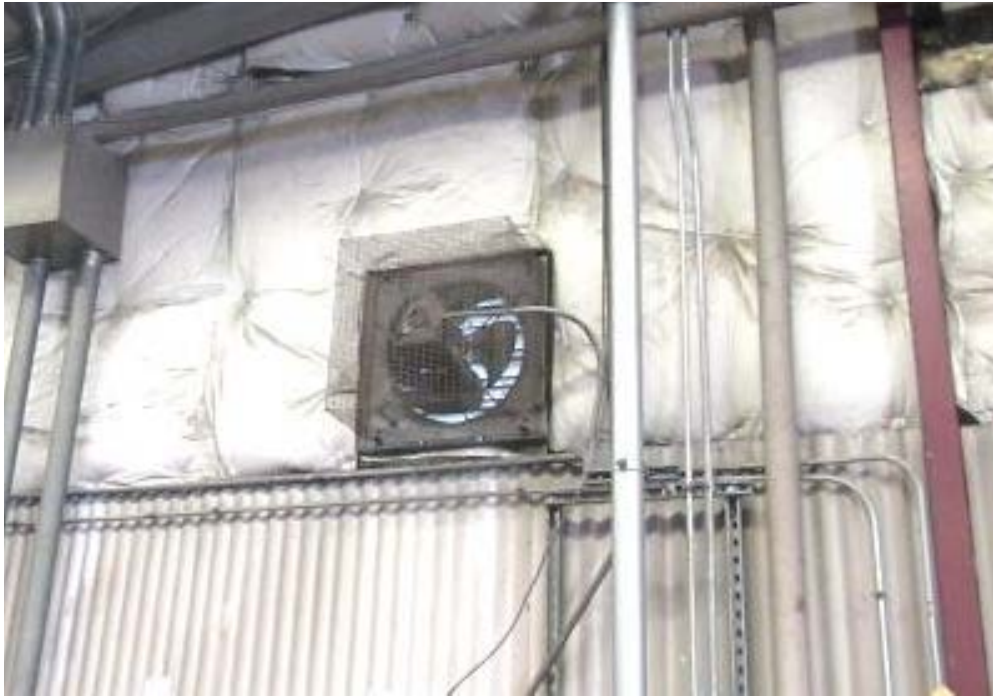
Picture 9

The garage/work areas have local exhaust fans throughout the building (Picture 9). In order for an exhaust fan to properly function, a source of air is needed (makeup air). No make-up air vents for the exhaust fans could be identified, apart from opening the garage doors.

Local exhaust vent

5. Provide local exhaust for fume/VOC-generating activities such as welding, including activating local exhaust fans; make repairs where necessary. If possible, provide make-up air vents, or continue to open doors when local exhaust is in use.

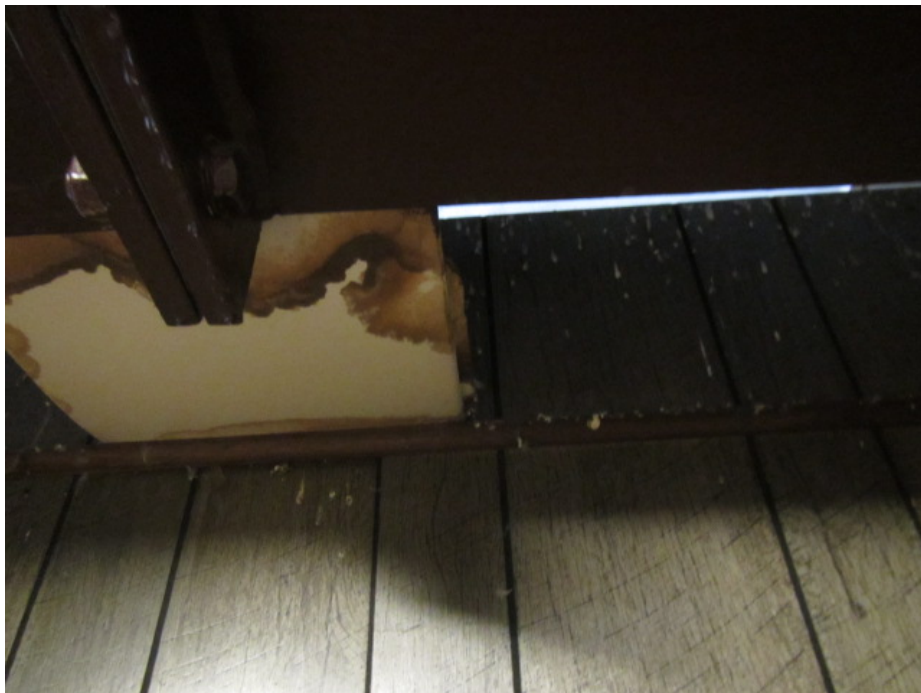
Picture 10

Water-damaged ceiling tile and bird wastes on wall

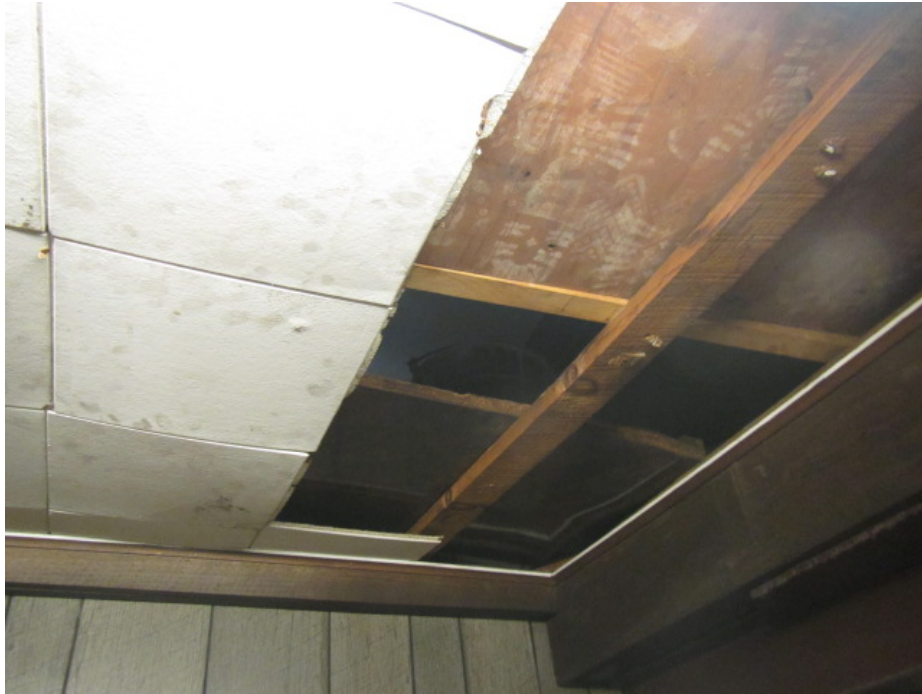
Picture 11

Failing/water-damaged ceiling

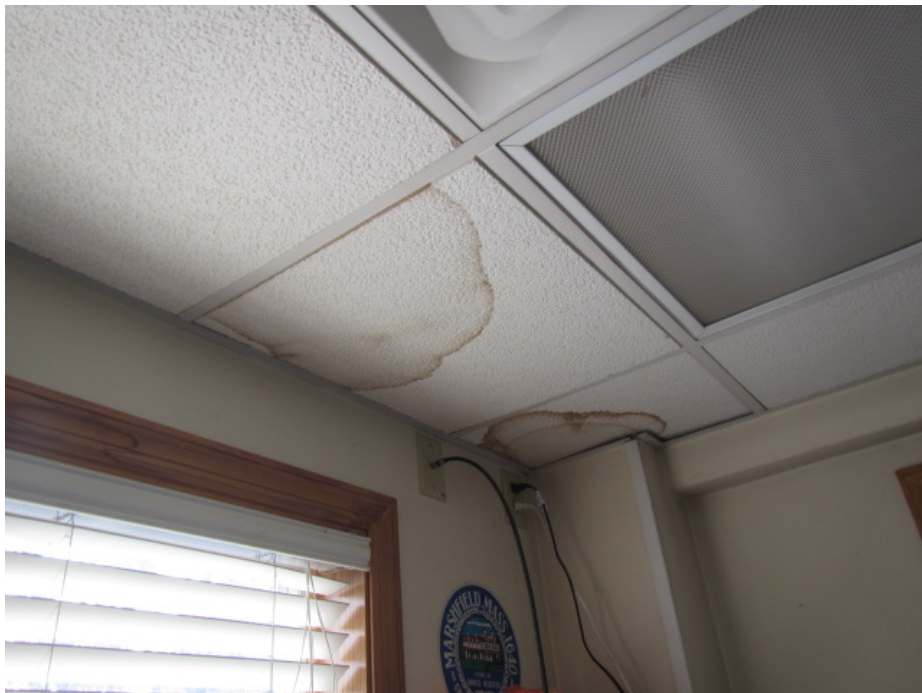
Picture 12

Water-damaged ceiling tiles

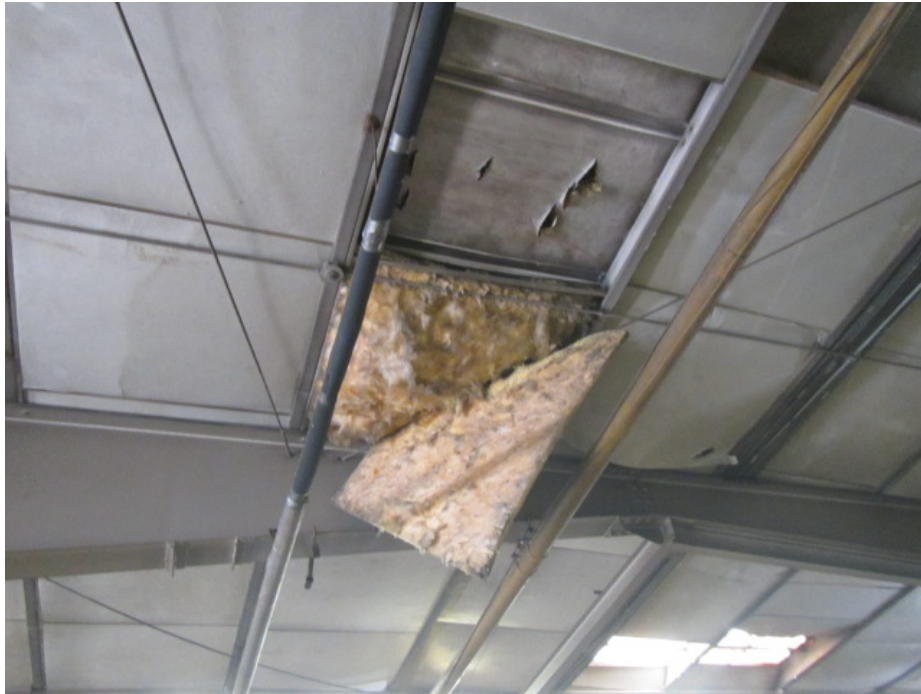
Picture 13

Failing insulated ceiling tiles

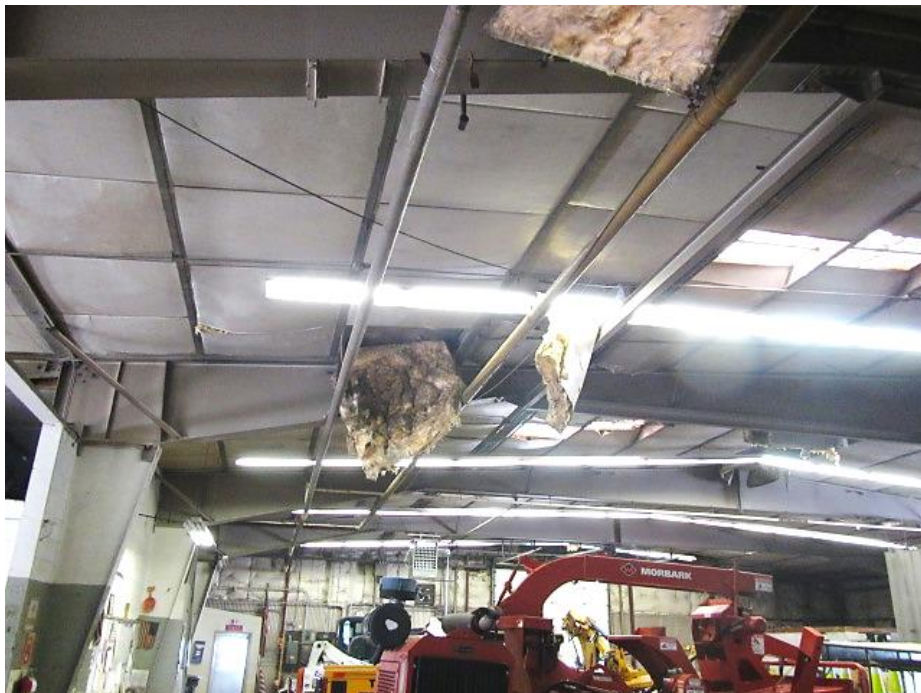
Picture 14

Failing insulated ceiling tiles

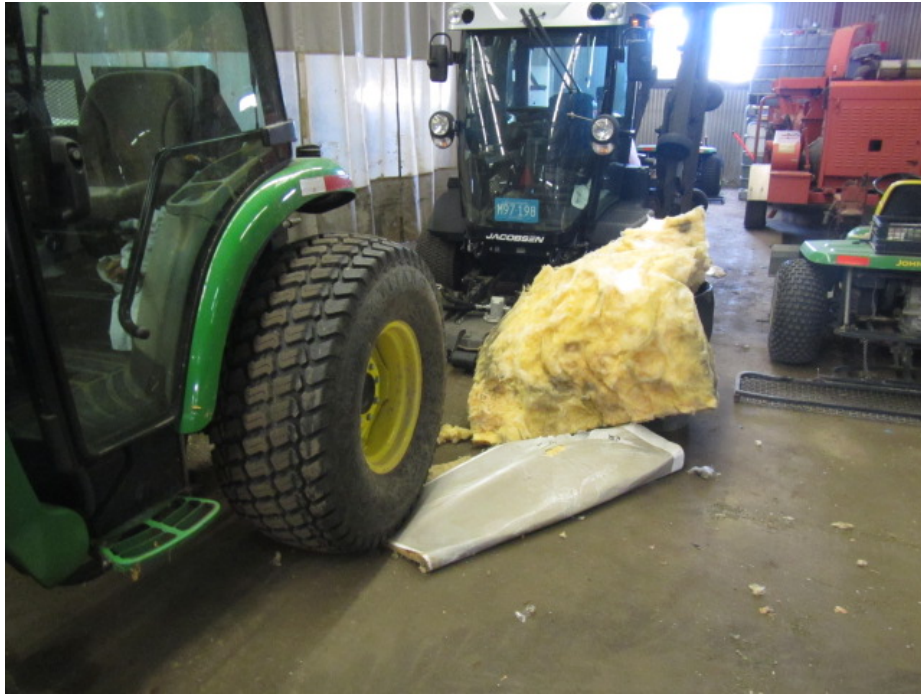
Picture 15

Insulated ceiling panels on the floor of garage

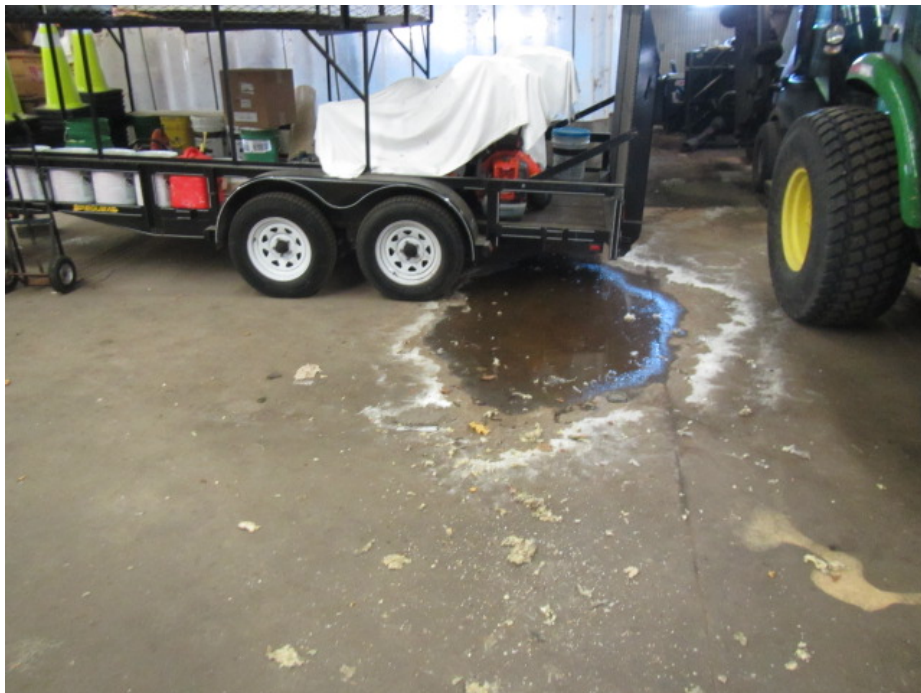
Picture 16

Active leak/puddle in garage, note tarp to protect equipment on trailer

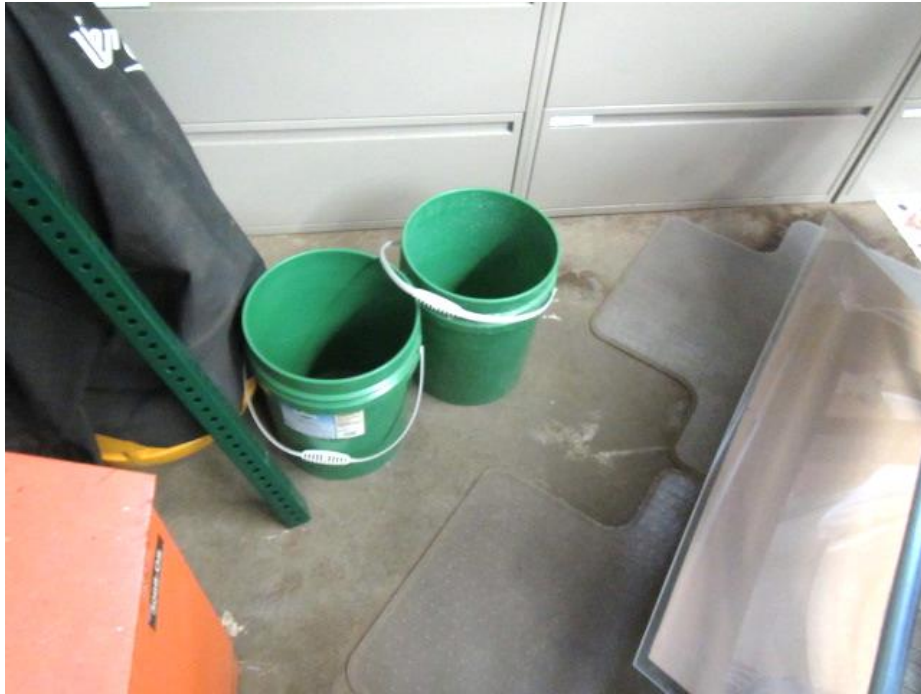
Picture 17

Buckets to catch leaks

6. Seal any holes/breaches/pathways (e.g., damaged skylights, holes in exterior walls) to prevent uncontrolled drafts/moisture and pest entry.
7. Ensure any containers used to catch leaks are monitored and emptied regularly to prevent stagnant water and odors.

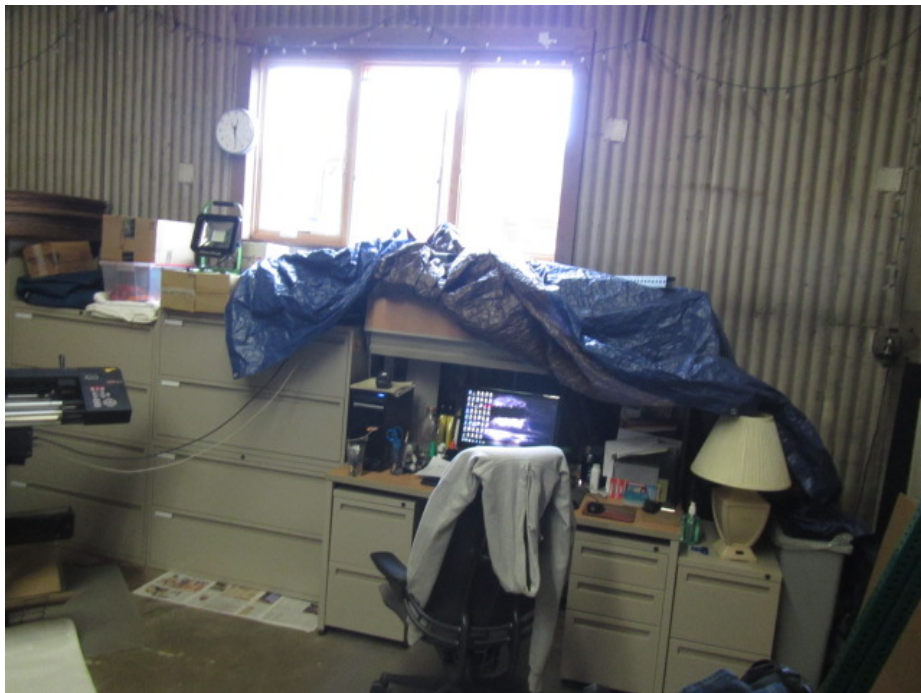
Picture 18

Tarp indoors to protect office materials

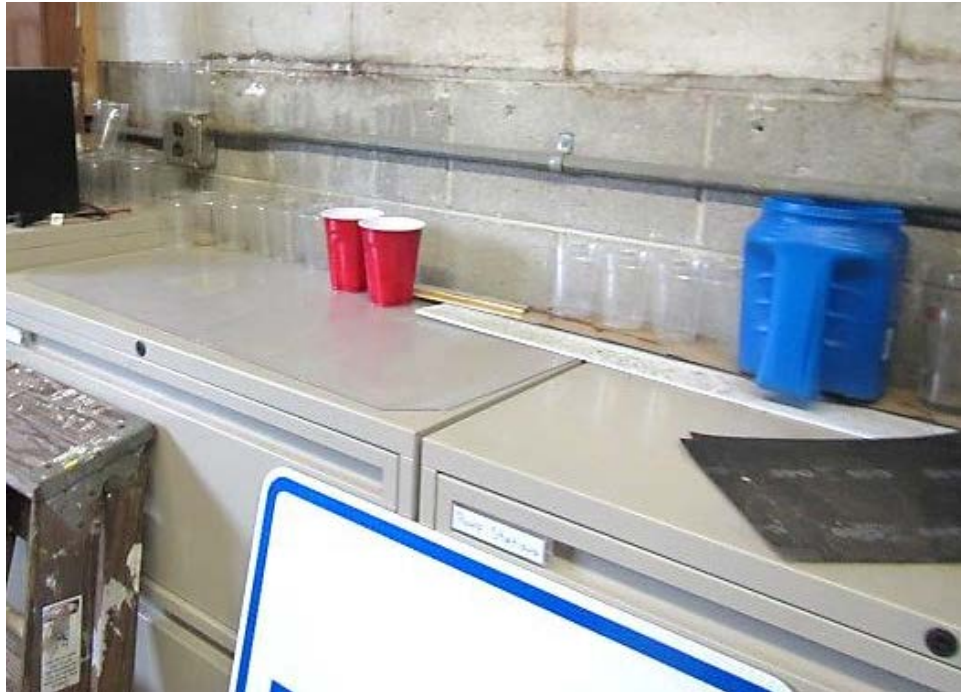
Picture 19

Cups/containers to catch leaks

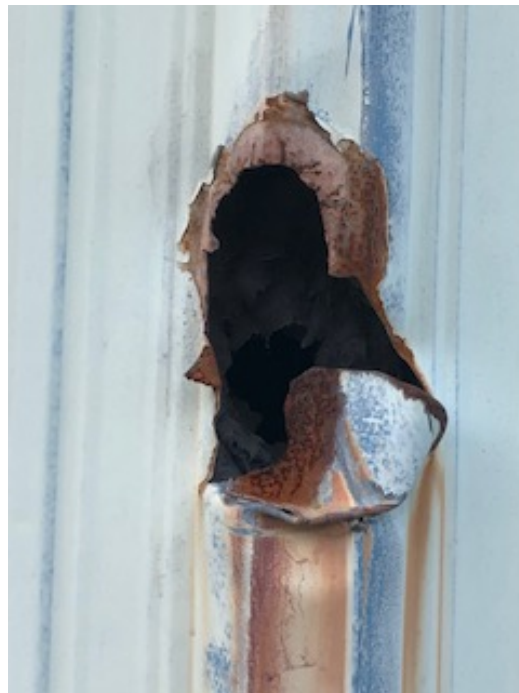
Picture 20

Hole/damaged exterior wall

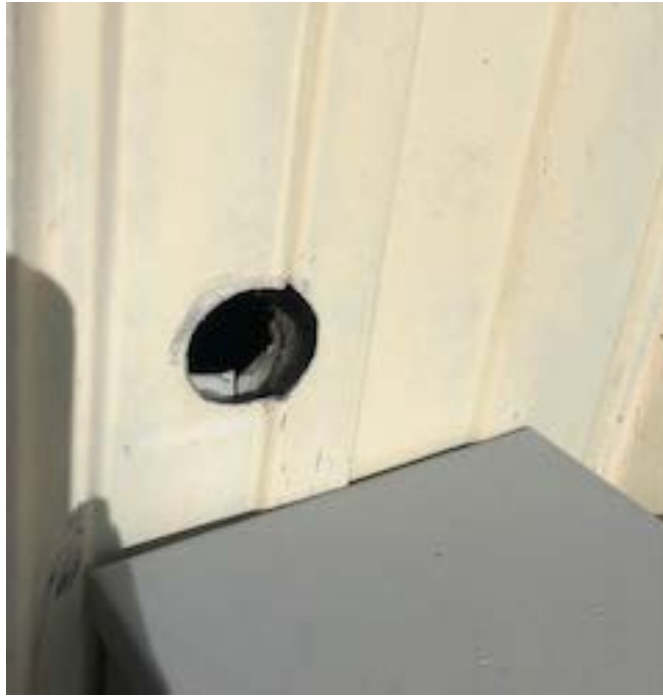
Picture 21

Open utility hole in exterior wall

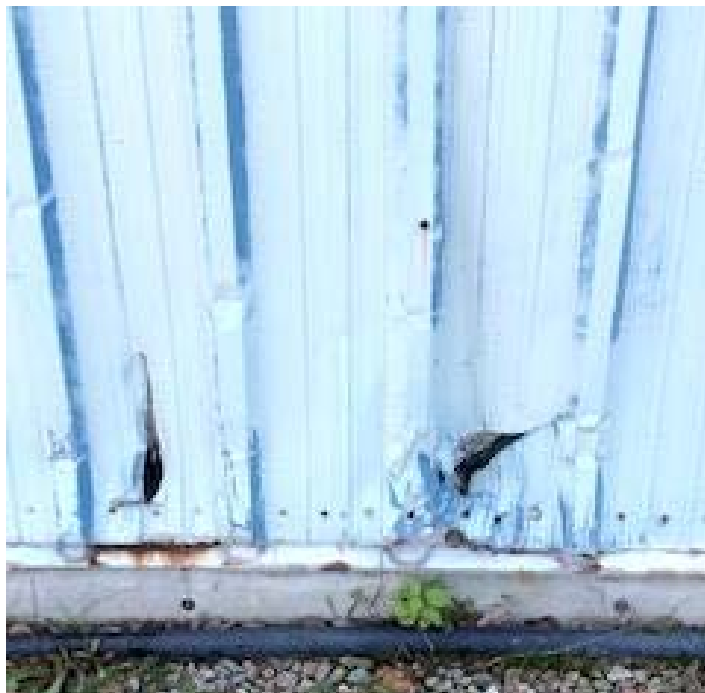
Picture 22

Damaged exterior wall

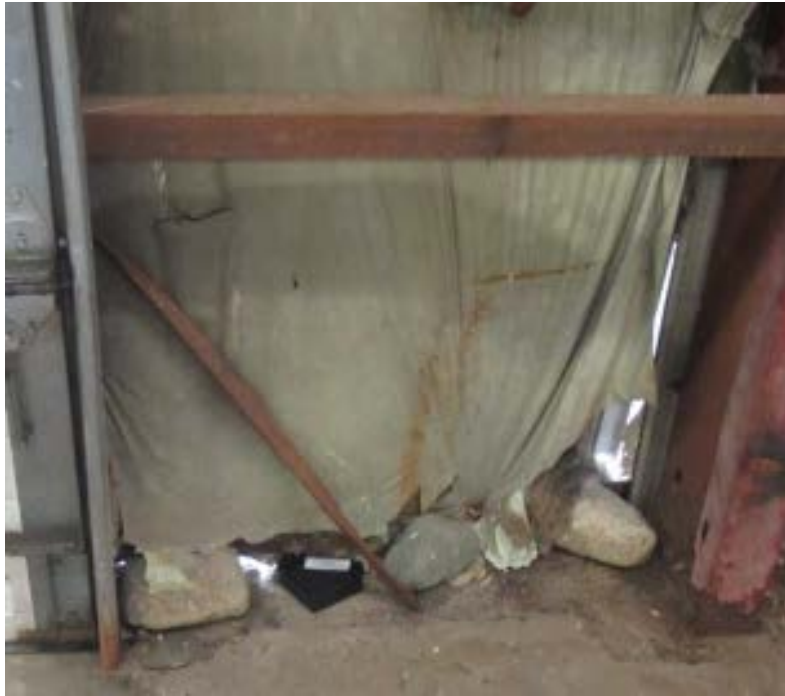
Picture 23

Interior view of damaged wall, note large rocks used to block holes

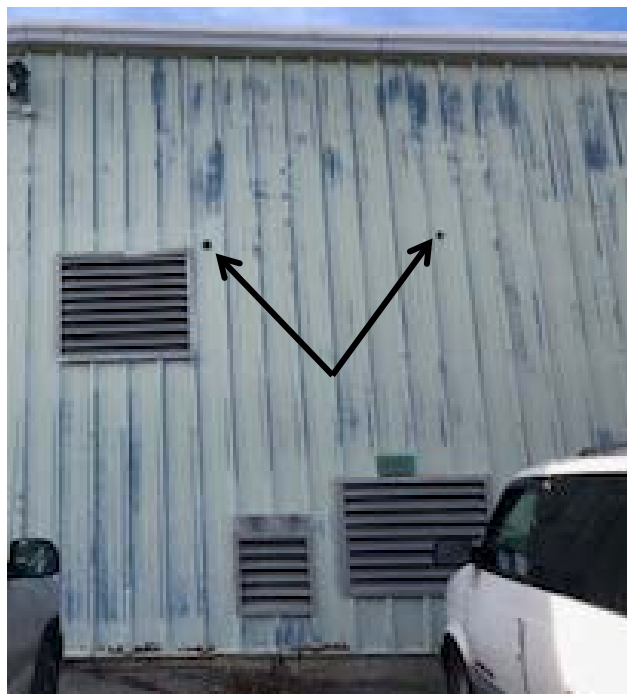
Picture 24

Holes left open after pipes removed (arrows)

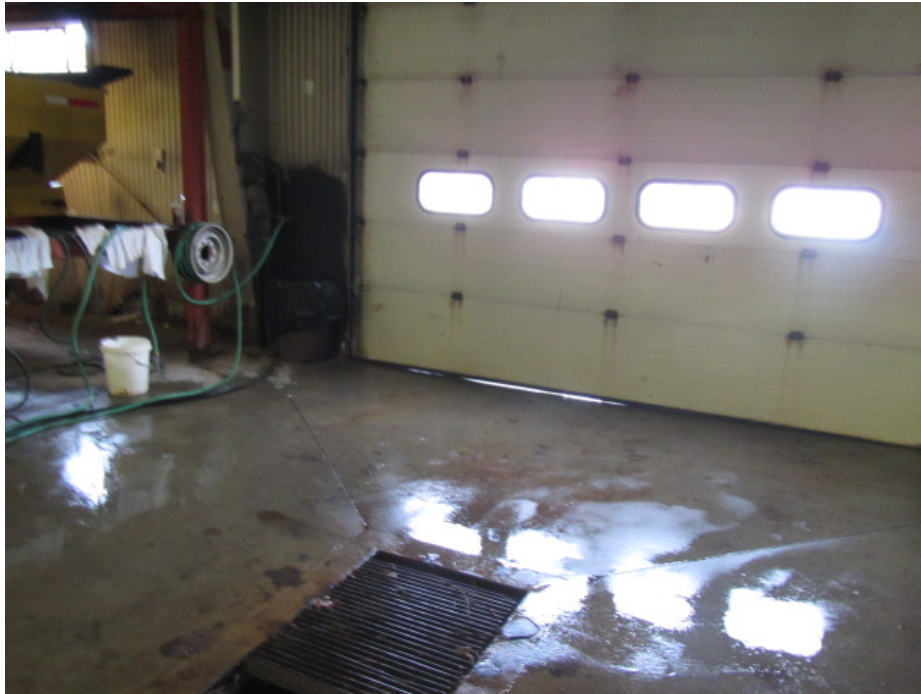
Picture 25

Gaps/light under garage door

8. Consider installing digital readout carbon monoxide detectors in occupied areas of the building.
9. Install weather-stripping on exterior and garage/bay doors, if doors cannot be made tight to prevent drafts/moisture/pests, repair or consider replacing. Ensure tightness of doors by monitoring for light penetration and drafts around doorframes.

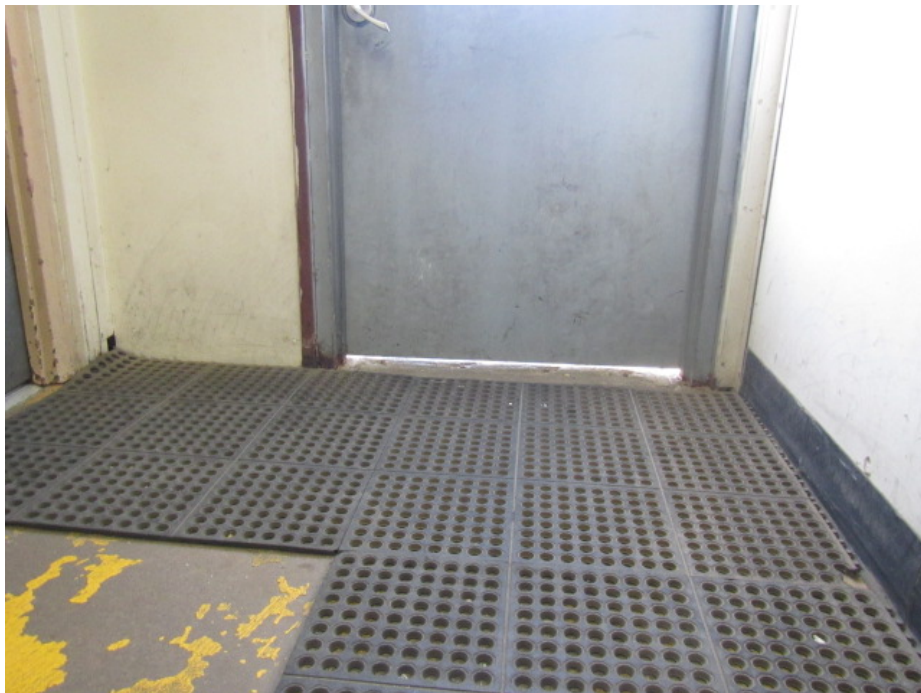
Picture 26

Gap/light penetrating beneath exterior door

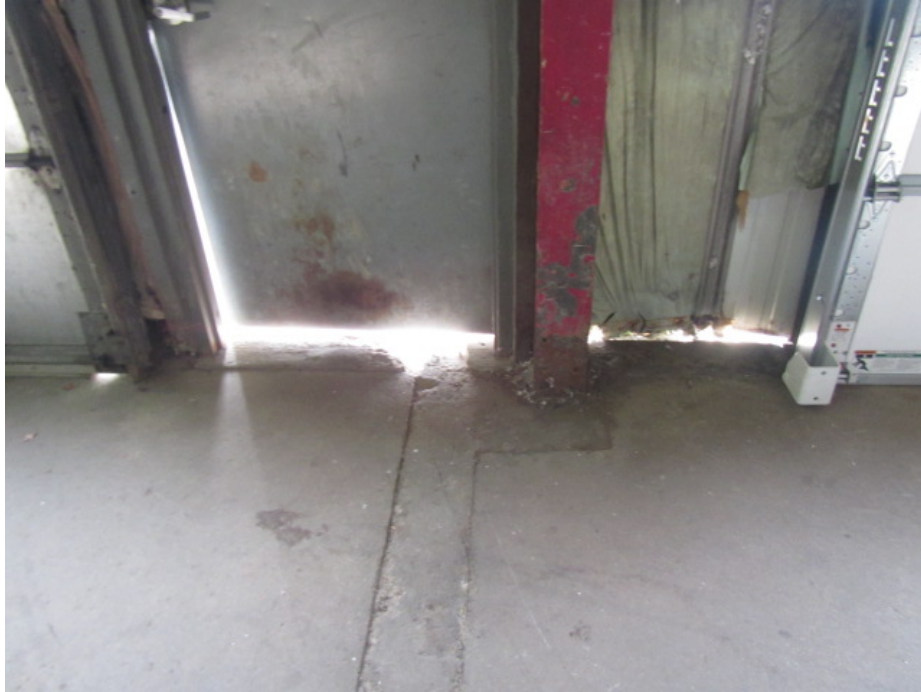
Picture 27

Gaps/light penetrating around door/damaged wall

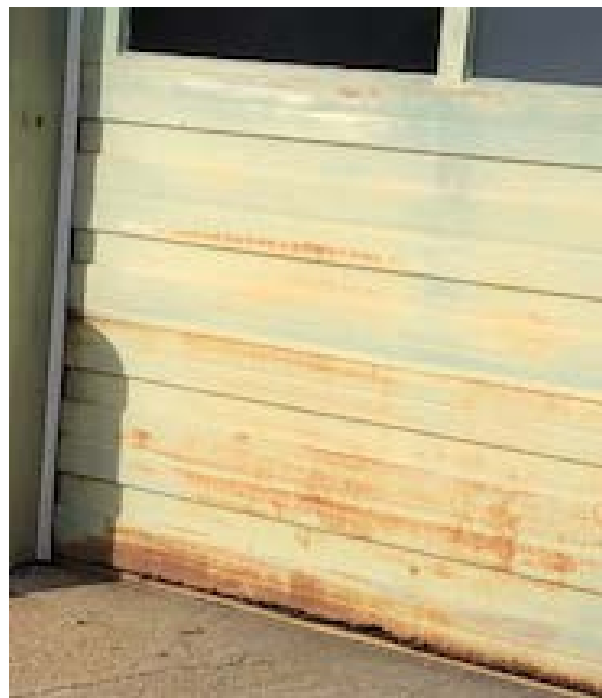
Picture 28

Rusted/corroded garage door

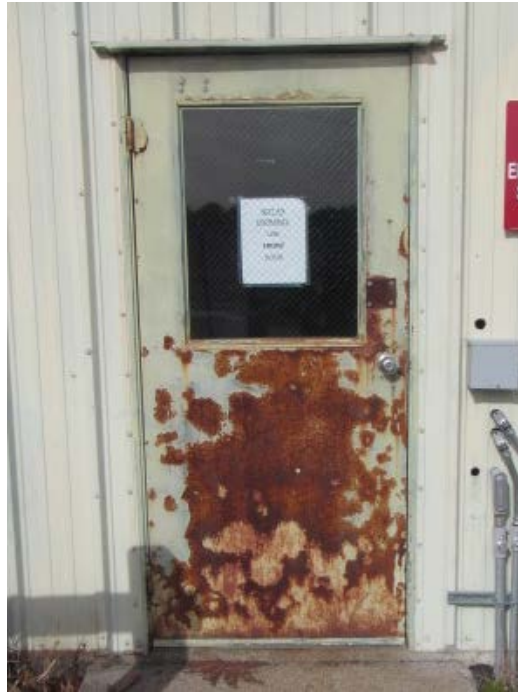
Picture 29

Damaged/corroded exterior door

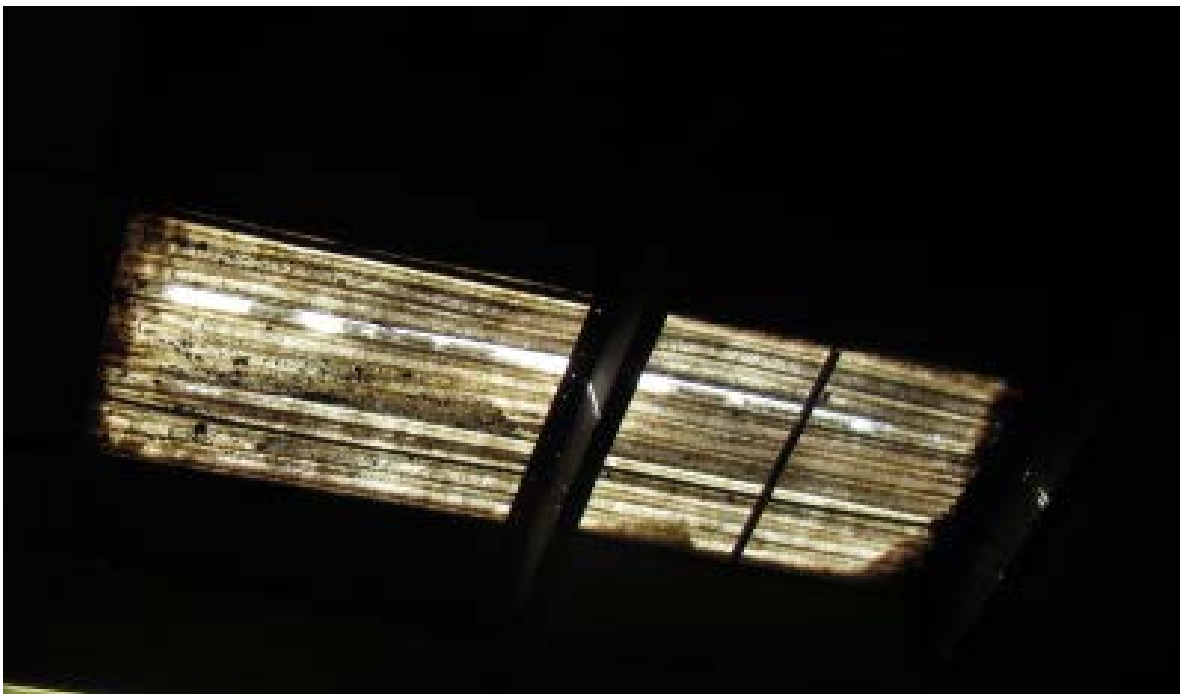
Picture 30

Breach in damaged skylight, note it runs the entire length

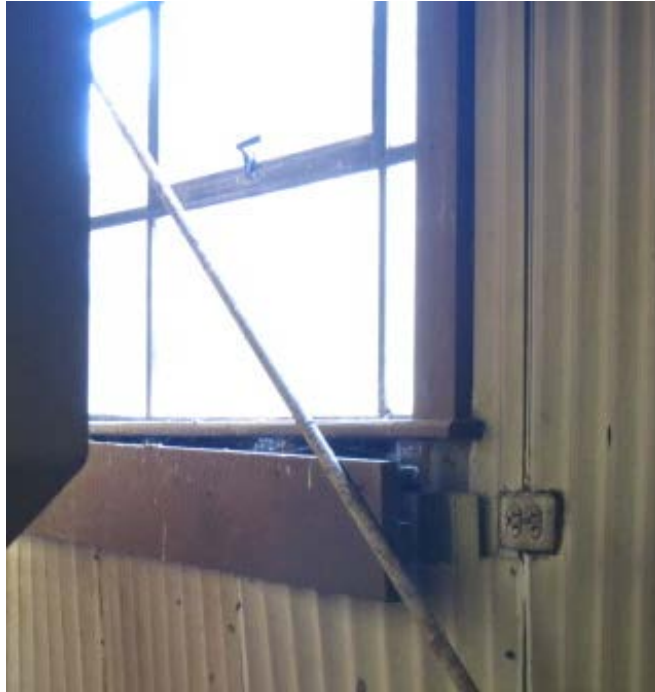
Picture 31

Breach between windowsill and wall

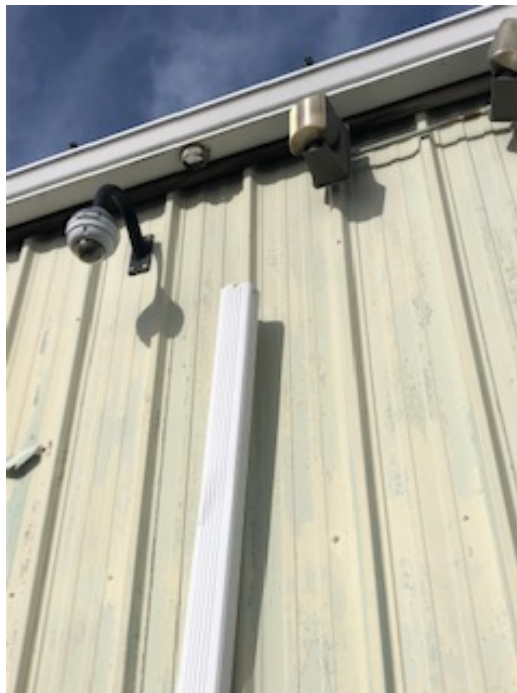
Picture 32

Disconnected downspout

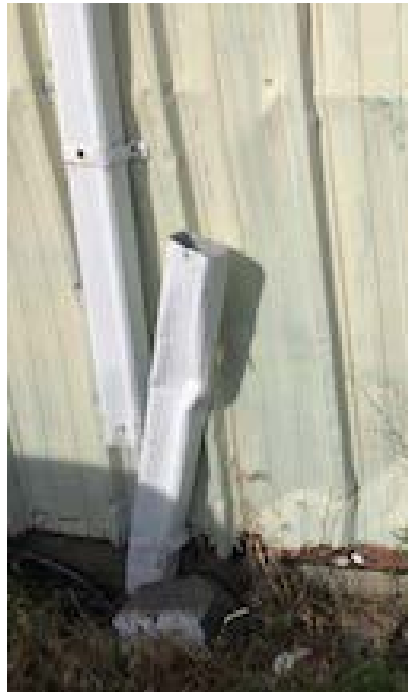
Picture 33

Disconnected downspout

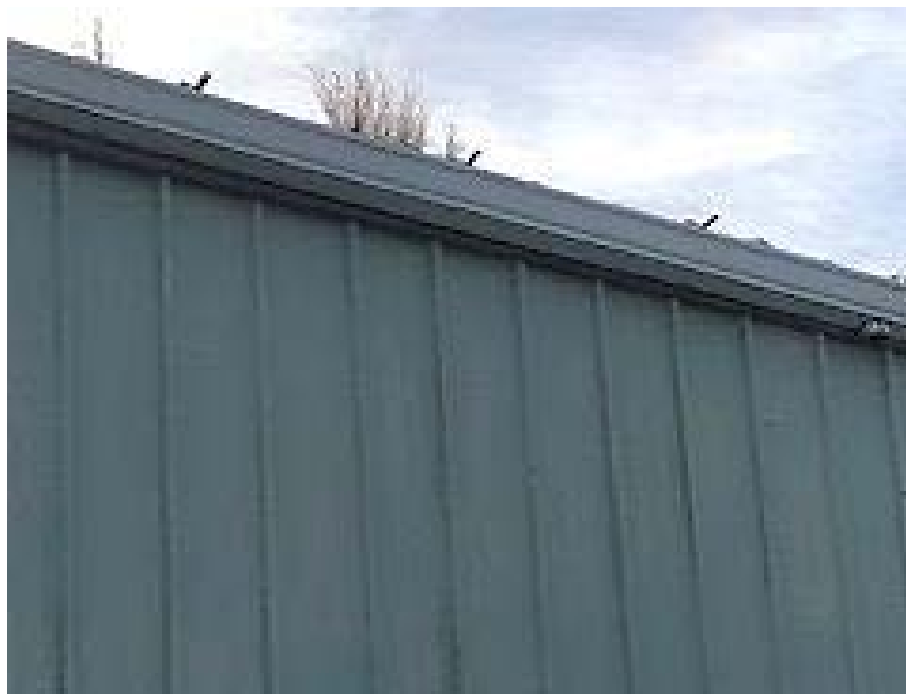
Picture 34

Plant growth in gutter

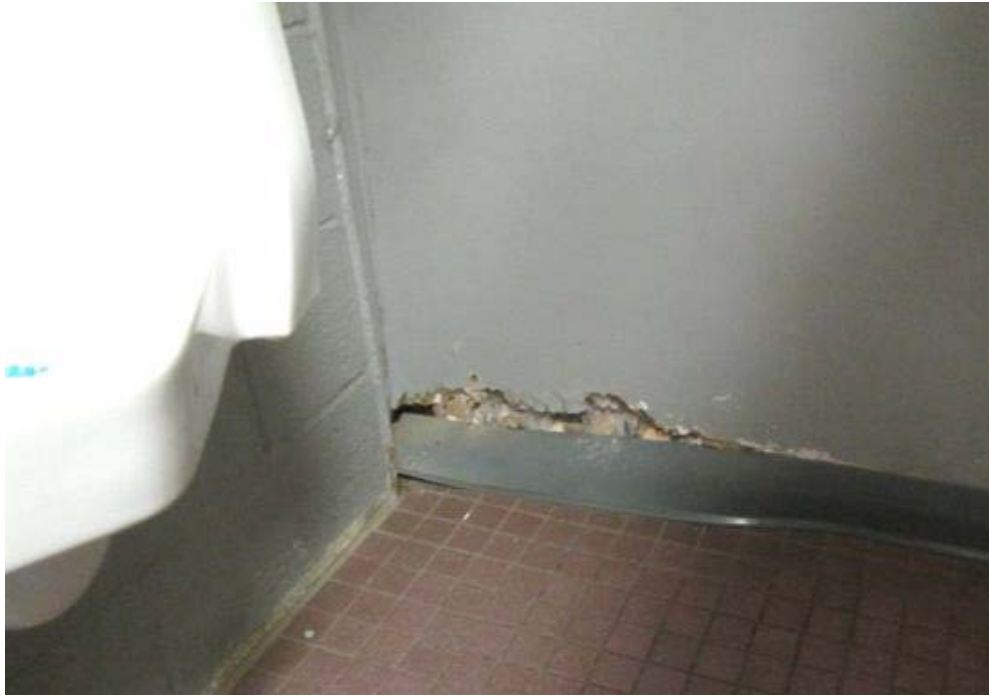
Picture 35

These conditions may be a source of water/leaks damaging stored and building materials, such as drywall in the men's restroom (Picture 35), as well as serving as a pathway for pests/animals in the building.

Water-damaged drywall in men's restroom

10. Remove water-damaged drywall in men's restroom.
11. Remove and discard all water-damaged stored materials. Any items to be preserved should be inspected for water damage and cleaned before being stored in a dry location.

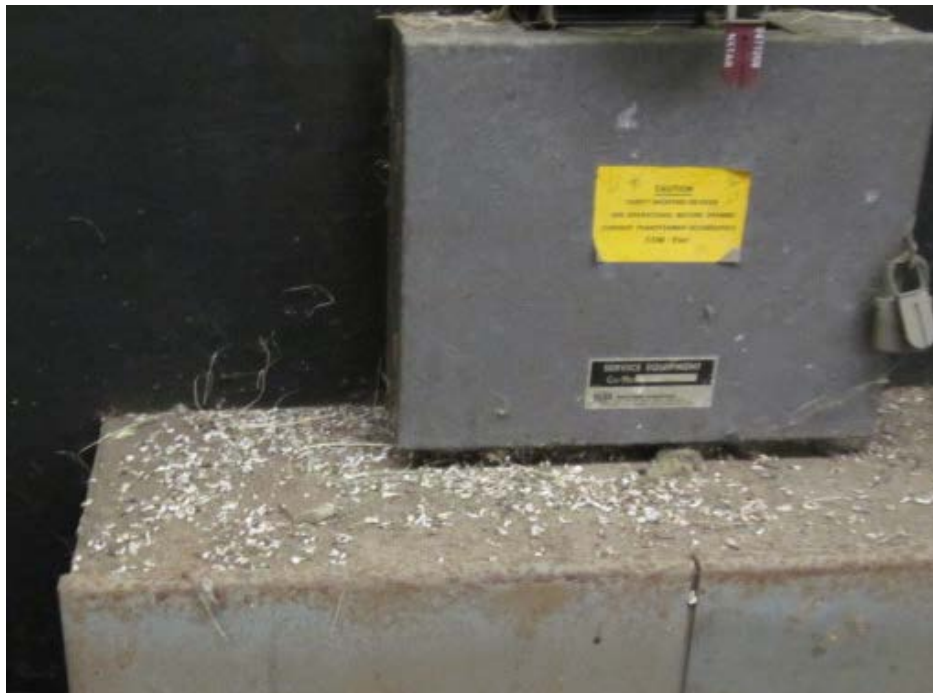
Picture 36

Bird wastes/nesting material on flat surfaces

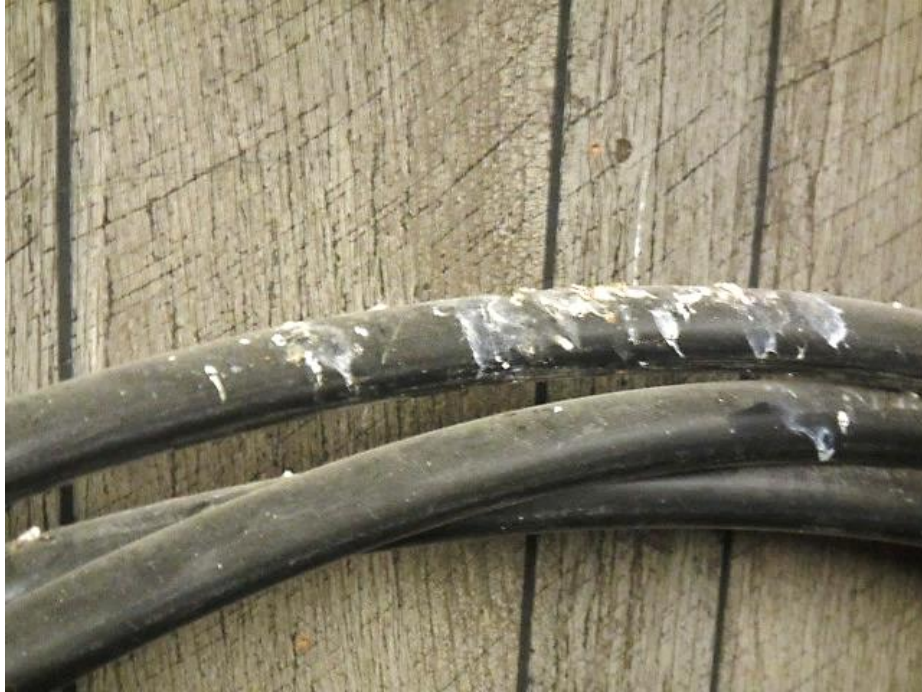
Picture 37

Bird wastes
